# Evaluation of Asphalt Road Cracks, Damages and the reasons for its occurrence using visual inspection Technology (PCR)

## Case study The Existing Road linking between (Fam Molga and Soug El Ahead) Area, Tarhunah- Libya

Basheer M. K. Alnnaas, Rafiq Aldin Mohamed Juma<sup>\* 2</sup> and Mohammed R. Almousi<sup>3</sup>  
<sup>1,2,3</sup> Faculty of Engineering, Azzaytuna University, Soug Elahed, Tarhuna Libya  
[b.alnnaas@azu.edu.ly](mailto:b.alnnaas@azu.edu.ly), [r.alabase@azu.edu.ly](mailto:r.alabase@azu.edu.ly), [m.almousi@azu.edu.ly](mailto:m.almousi@azu.edu.ly)

Publishing Date: 31 March 2026

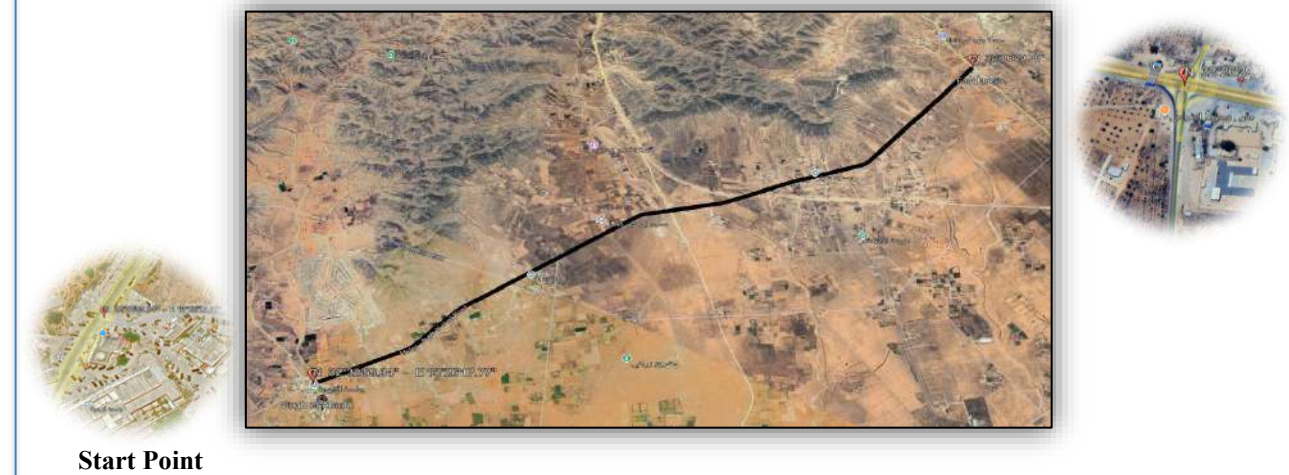
**Figure No (1) Location of the study area.**  
Length extends (13,500) kilometers in Two direction (one lane each)  
Start Point- N 32° 26' 29.55"      E 13° 22' 11.41"  
End Point - N 32° 32' 55.34"      E 13° 26' 17.77"

The study area is the road linking the two areas of Fam Molga and Souk El Ahad, as shown in the map attached to Figure No 1 and the table of geographic coordinates for the starting point and the ending point, Table No. 1.

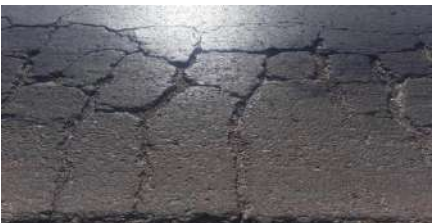
| sector No | LOCATION | | Crack Type | Photograph of the case |
|---|---|---|---|---|
| 2 | N 32° 30' 37.35" | E 13° 24' 50.20" | High intensity crocodile cracks in the road shown. | |

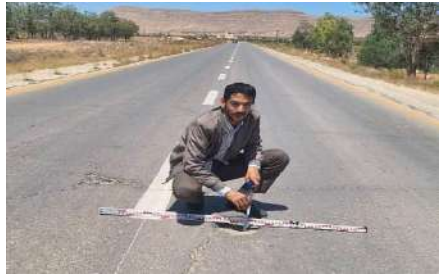
| 3 | N 32° 30' 37.3" | E 13° 24' 50.7" | Shows the drop in tire track on the road | |

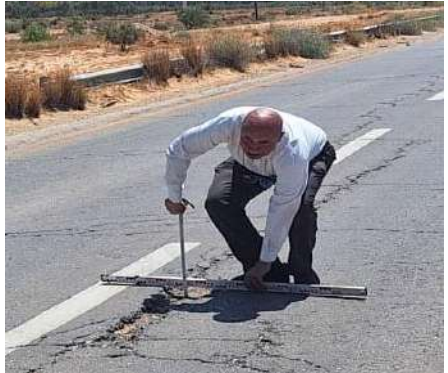
| sector No | LOCATION | | Crack Type | Photograph of the case |
|---|---|---|---|---|
| 4 | N 32° 30' 37.11" | E 13° 24' 51.21" | High intensity descent on the way | |

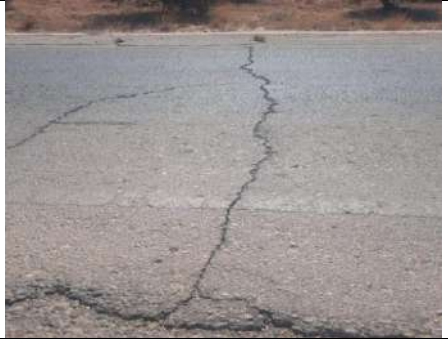
| sector No | LOCATION | | Crack Type | Photograph of the case |
|---|---|---|---|---|
| 2 | N 32° 30' 37.11" | E 13° 24' 51.21" | Shows transverse cracks in the road | |

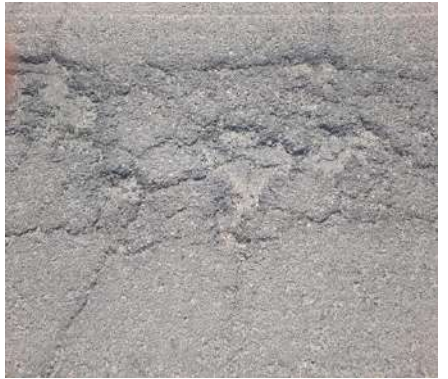
| sector No | LOCATION | | Crack Type | Photograph of the case |
|---|---|---|---|---|
| 5 | N 32° 30' 37.11" | E 13° 24' 51.21" | Shows crocodile cracks and potholes in the road | |

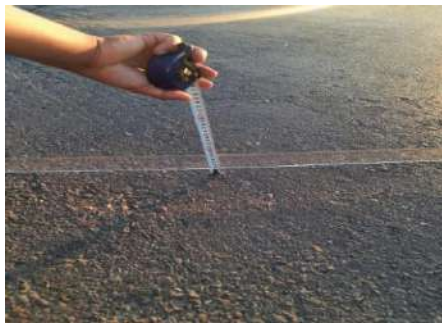
| 1 | N 32° 30' 37.11" | E 13° 24' 51.21" | Shows the drop in tire track on the road | |

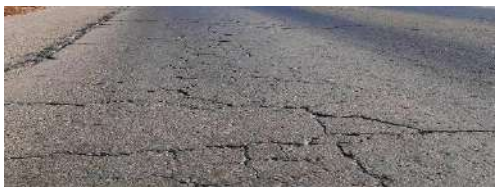
| Type and name of crack | Alligator or reticular cracks<br>التشققات التماسكية أو الشبكية | | | Longitudinal and traverse cracks<br>الشقوق الطولية والعرضية | | |
|---|---|---|---|---|---|---|
| | | | | N 32° 30' 33" , E 13° 24' 51.4"<br> | | |
| Type and name of crack | Bleeding of flushing<br>النزيف أو طفح الإسفلت | | | Side slits<br>الشقوق الجانبية | | |

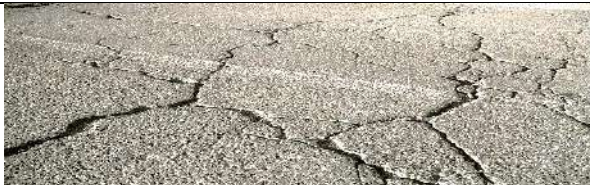
| Crack severity level | Low intensity | Medium intensity | High intensity | Low intensity | Medium intensity | High intensity |
| Pictures from the field survey of the study area | N 32° 30' 33" , E 13° 24' 51.4" | | | | | |

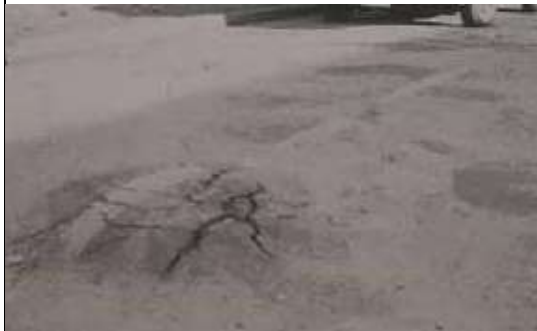
| Type and name of crack | Pushing shoving delaminating<br>زحف الطبقات | | | Rutting<br>التخدد | | |

| Pictures<br><br>from the<br>field<br>survey of<br>the study<br>area |

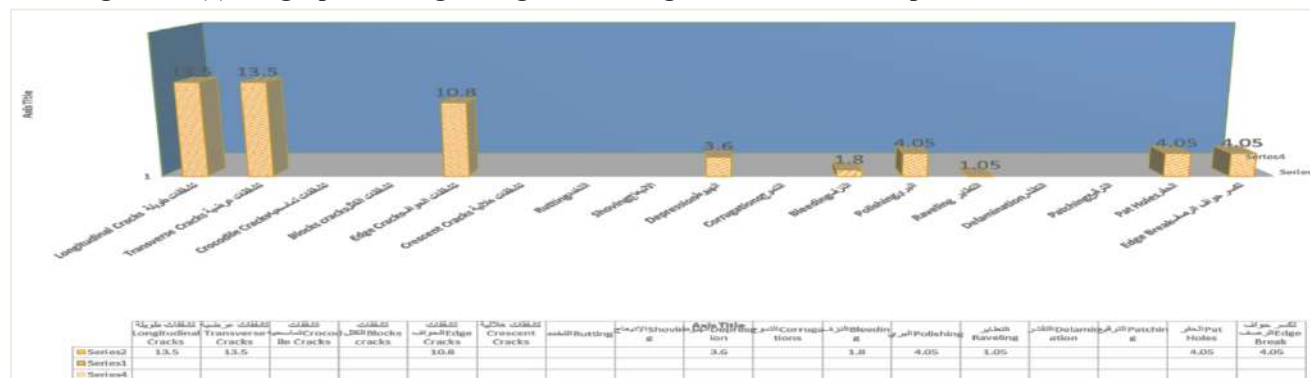
| <b>Project: A scientific research paper entitled The Asphalt Road Crack and Damage</b><br><b>Date of diagnosis: 10 /4/2025r Location: Tarhuna Road: Fam Malga, Souk El Ahad</b><br><b>Sector: The Second Sector number: 4 Sector distance: 2.3 km</b><br><b>Surface paving type: Number of lanes in each direction: 2 Width: 8 m</b> | | | | | | | | | |
|---|---|---|---|---|---|---|---|---|---|
| Poor | (PCR) Evaluation of pavement condition<br>= 100 - Total discount points<br>= (100 – 56.4)<br>= 43.6 % | | | | | | | | |

Figure No (7) is a graph showing A diagram showing the condition of the pavement in the third section
